BAY MARINE SURVEY, LLC

******* 2009 Pre-Purchase Condition and Value Survey of the 1977 Globe 46
“*****”**

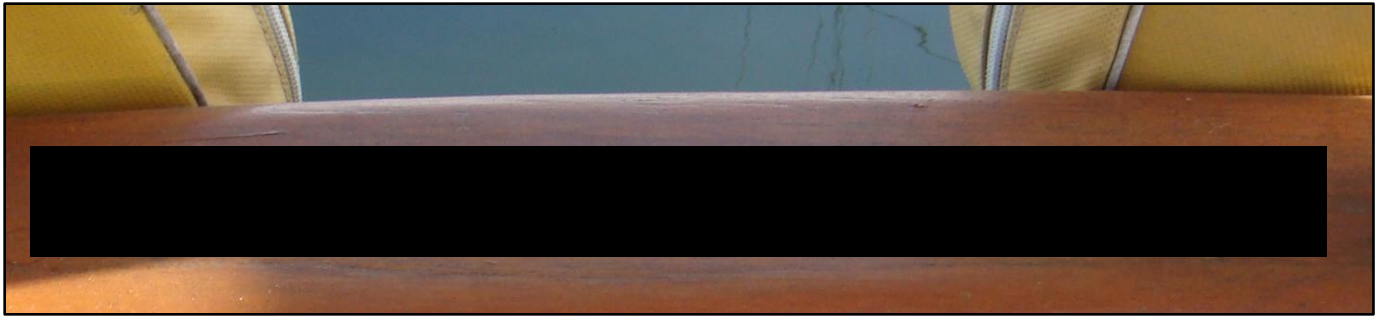
Hull identification number found on cap rail at stern
